## SB, Potential issue regarding wiring harness stop circuit, Snow Thrower, Single stage, MSB121, MSB121E, 2012-01

MSB121 (96181000700)

MSB121E (96181000800)

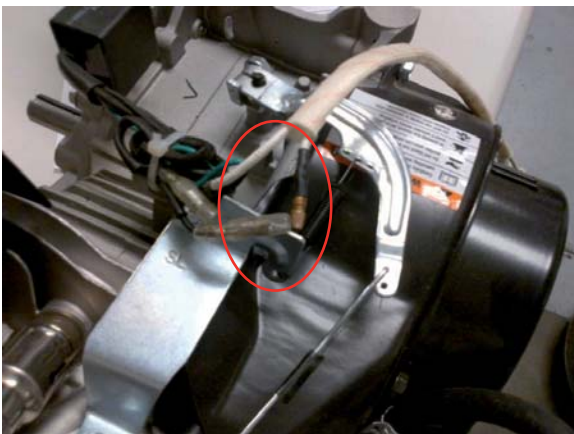
It has come to our attention, a small percentage of Husqvarna single-stage snow throwers powered by the LCT Storm Force series of engines produced in 2010 and 2011 and sold in European markets could have a bullet connector in the stop switch wiring circuit disconnected rendering the push / pull key stop switch inoperable for powering off the snow thrower engine . There is a complete engineering design change affecting the wiring harnesses for the 2012 model year.

To repair this condition on a **2010, 2011 model year** snow thrower requires reconnecting the bullet connector located on the top of the engine (see photo #1 below):

- A. Locate the engine stop circuit wiring at the top of the engine, wiretied to an aluminum boss on the top of the crank case.
- B. Plug the male bullet connector of the wire from the stop switch into either of the two female bullet connector terminals.
- C. Ensure the wires are rebundled, and wire tied, back to the aluminum boss on the top of the engine.

Reconnecting the bullet connectors shown in the above photos will repair the engines such that the push / pull key stop switch will be operational.

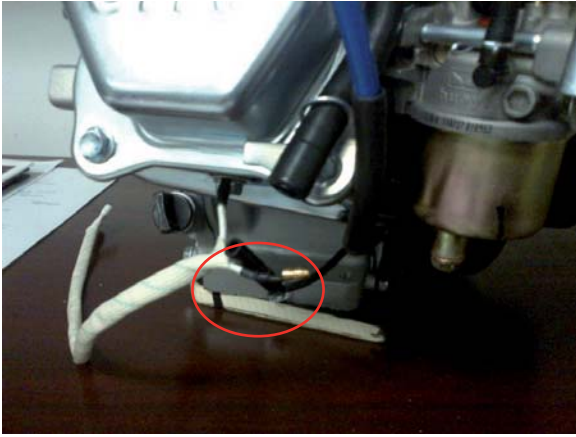
To repair this condition on a **2011 model year** snow thrower requires reconnecting the bullet connector located below the cylinder head of the engine (see photo #2 below):

- A. Locate the engine stop circuit wiring under the valve cover of the engine.
- B. Plug the male bullet connector into the black, rubber, female, bullet connector receptacle.
