SERVICE BULLETIN

To: All Dealers and Customers
Bulletin Number: B170008A
Date: 16-May-2017
Brands: McCulloch, Gardol
Product: Rear Discharge Tractor
Dates Produced: 30-Nov-2016 to 10-Mar-2017
Affected Market(s): Europe

INSPECTION AND REWORK INSTRUCTIONS

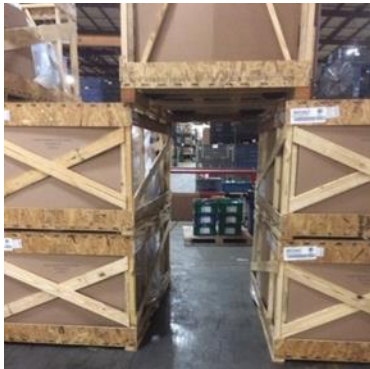
Step 1. Part number of the bracket is visible from under the unit. The bottom of the unit can be accessed by stacking units as shown below, or by following your locally approved method of work for gaining access.

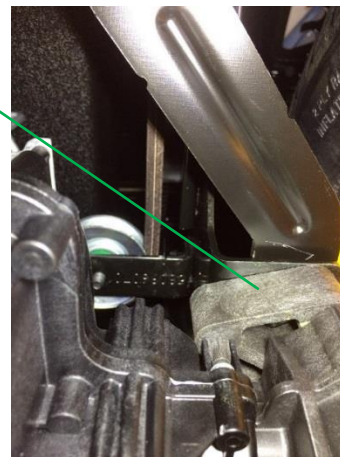
435645

Step 2. Using a flashlight, look for the bracket on the inside of the left hand side chassis, above the rear axle shaft. Confirm part number stamped on bracket. If part number stamped is 435645, replace. If part number stamped is 580960701, bracket is correct. If correct, proceed to step 5. If incorrect, proceed to step 3.

Replace part

Step 3. To replace incorrect bracket, use 14 mm (9/16") wrench or socket to loosen and remove the zinc colored screw behind the left rear tire. The bracket will release from the chassis. Remove bracket and replace with preassembled bracket. Use care to not twist the belt with removing or reinstalling bracket.

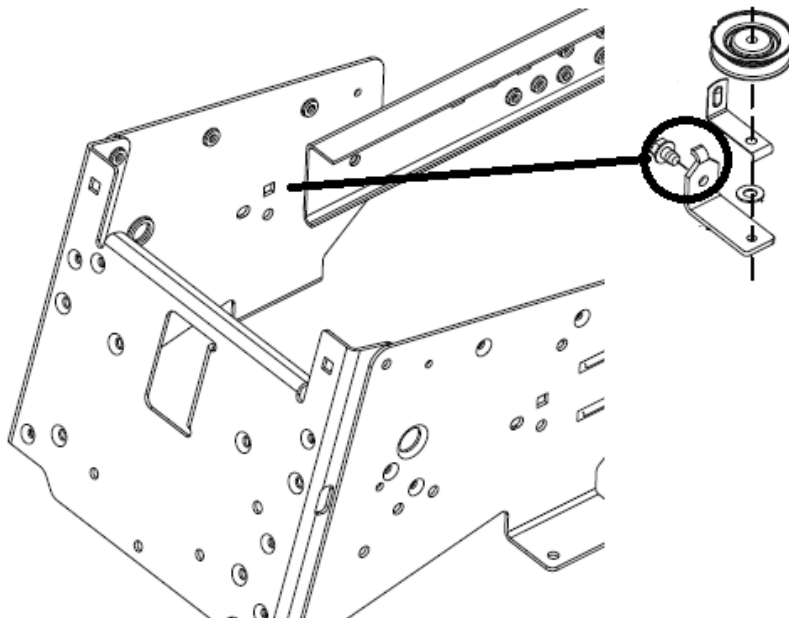
Step 4. When replacing bracket, ensure tang on bracket is locked into chassis. Tighten bolt and ensure belt is between keeper and pulley.

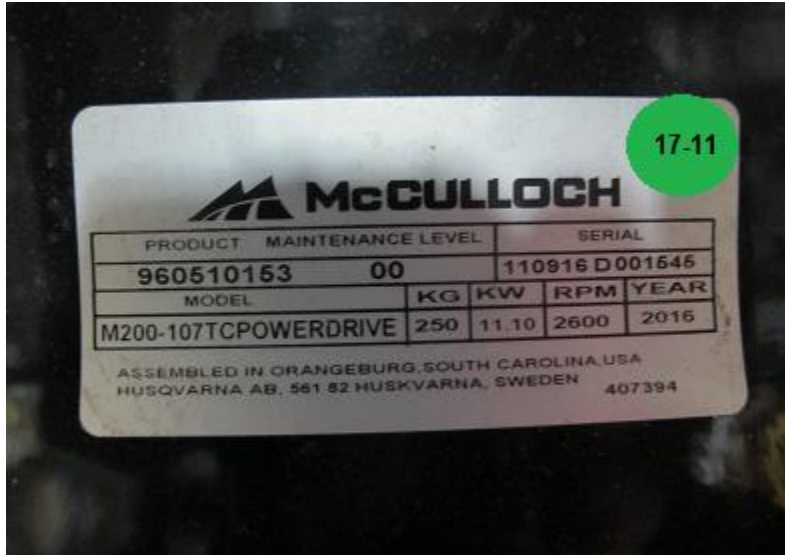
Step 5. After unit has been inspected and found to be correct or replaced with correct bracket, place green dot on packaging with “17-11” if unit is still crated. If unit is not boxed, mark the serial tag with a green dot and “17-11.”
